Perfect CC

Golf Course Evaluation

Golf Club Consulting, Inc.

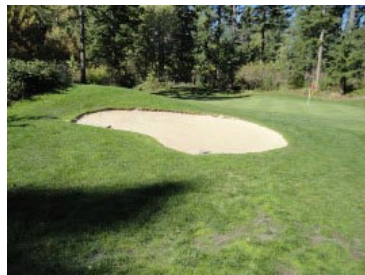
The last few years, the golf course maintenance department has renovated a few bunkers each year with a total of 18 bunkers being renovated to-date. These bunkers are in very good condition and all are located on the back nine.

Bunker on #14: renovated

The existing bunker renovation program should be accelerated because the playability of the bunkers is very different from the front nine to the back nine.

- b) Rating of component during site visit: C
c) Importance of component: Somewhat
d) Was all information gathered, provided or available? Yes
e) Concerns:
 - Quality of sand in the bunkers.
 - Rocks in bunkers
 - Drainage in and near bunkers
- f) When should the concerns be corrected? As determined
g) Actions needed to correct: Continue in-house bunker renovations

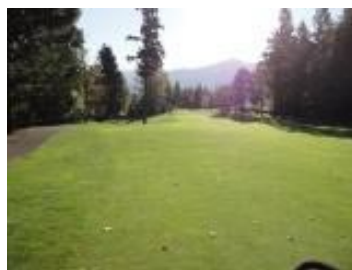
- a) The total size of the fairways is approximately 40 acres, which is average for a golf course the length *Perfect CC*. The fairway surfaces are relatively free of turf weeds and were generally uniform.

The thatch levels vary greatly throughout the course. Thatch is a layer of dead grass directly below the visible grass. Some thatch is desirable, but it should be less than 1/2" in depth. The thatch levels were excessive on #2, 4, 8, 14 & 15 and would be of some concern. Excessive thatch will cause the fairways to "hold" moisture and increase insect and disease infestations. Presently, the fairways are being "core" aerified and topdressed periodically to help reduce the turf thatch. Thatch removal is a process that must be dealt with on an annual basis and I feel that the present fairway core aerification and topdressing are VERY important practices to continue. The holes created by core aerification open channels for root development and water movement and will greatly improve surface drainage.

Fairway #11

The quality of the surfaces is due in part to the high mowing frequency that is being done along with the application of growth regulator applications. Knowing that labor use is a high concern of ownership, I recommend reducing the mowing frequency to 2 or 3 times per week. This should not have a significant impact on the quality of the fairway surfaces and this will "free-up" labor for other tasks on the golf course.

Dollar spot is the primary disease concerns of the fairways. The short roots of the fairway turf will make the fairways especially susceptible to dollar spot damage when the disease occurs. Thus, I highly recommend implementing routine applications for the prevention of turf dollar spot.

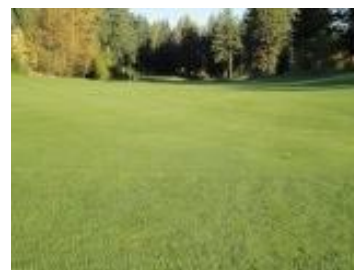
Fairway #18

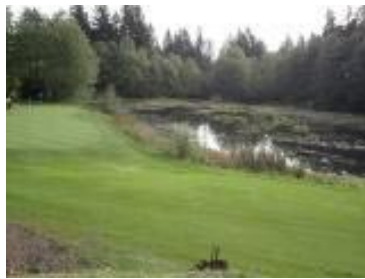
The main issue with the lakes is they all contain a significant growth of algae and weeds. When I inquired about this, I was told that *Perfect CC* has not received many negative comments on the weeds and algae. To a person that just toured the golf course for the first time; the existing state of the lakes was a very big negative.

Lake #3

Because I feel the weed growth in the lake is a significant negative to a club user, I recommend that the club contacts a local company that specializes in lake quality management for specific advice on how to efficiently address the weeds and algae.

- b) Rating of component during site visit: **C**
c) Importance of component: **Somewhat important**
d) Was all information gathered, provided or available? **YES**
e) Concerns:
- **Weed and algae growth.**
f) When should the concerns be corrected? **ASAP**
g) Actions needed to correct concerns? **Reduce the weed and algae growth.**

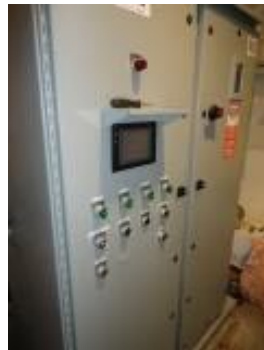
The delivery capacity of the pump station is 1000 GPM @120 PSI, which is more than adequate for a golf course the size of *Perfect CC*. It has been maintained well in the past and many good improvements have been made in the last few years.

Pump station control panel

Being the pump station's role is very important to the condition of the golf course; I highly recommend that *Perfect CC* continues making the pumping station a high priority.
